LA LAGUNA DE SAN GABRIEL

Historic Structures Report and Preservation Plan

Prepared by
Garavaglia Architecture, Inc

31 December 2008

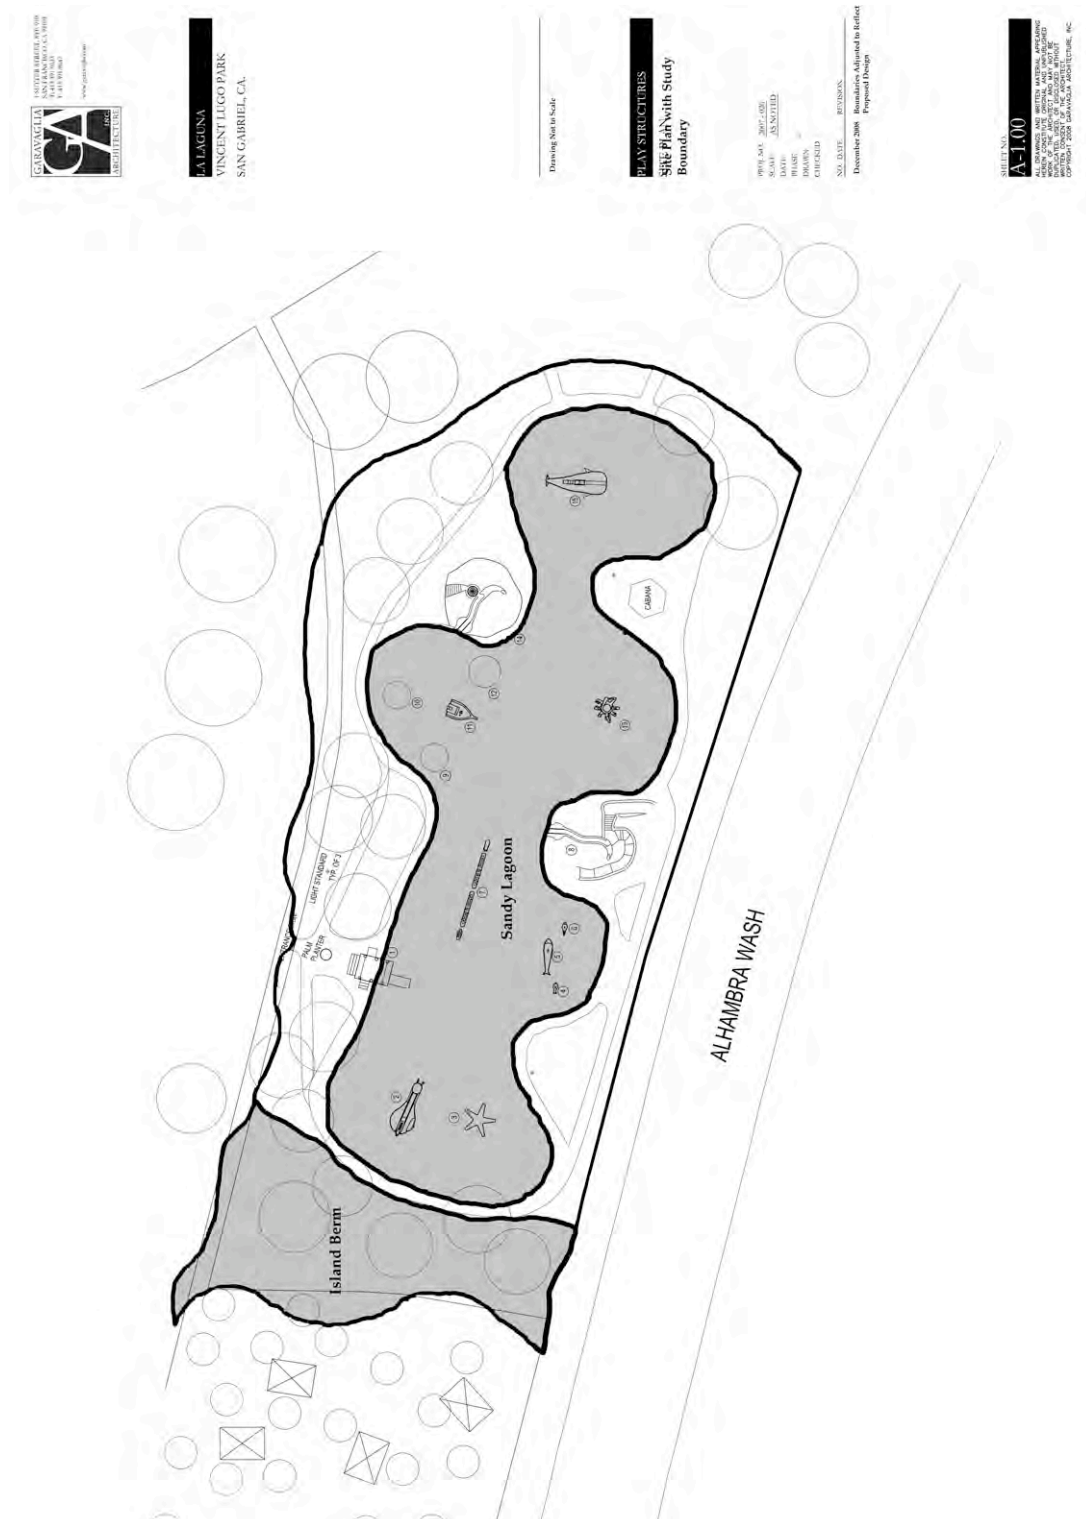
Figure 1. This site plan shows the boundaries of La Laguna de San Gabriel as agreed upon by the City of San Gabriel and Friends of La Laguna. These boundaries mark the official extent of the La Laguna as a cultural landscape. The numbers refer to the photo key in Figure 2. The shaded areas are specific zones within La Laguna that are discussed throughout the text. A larger version is presented in Appendix C. Source: Garavaglia Architecture, Inc.

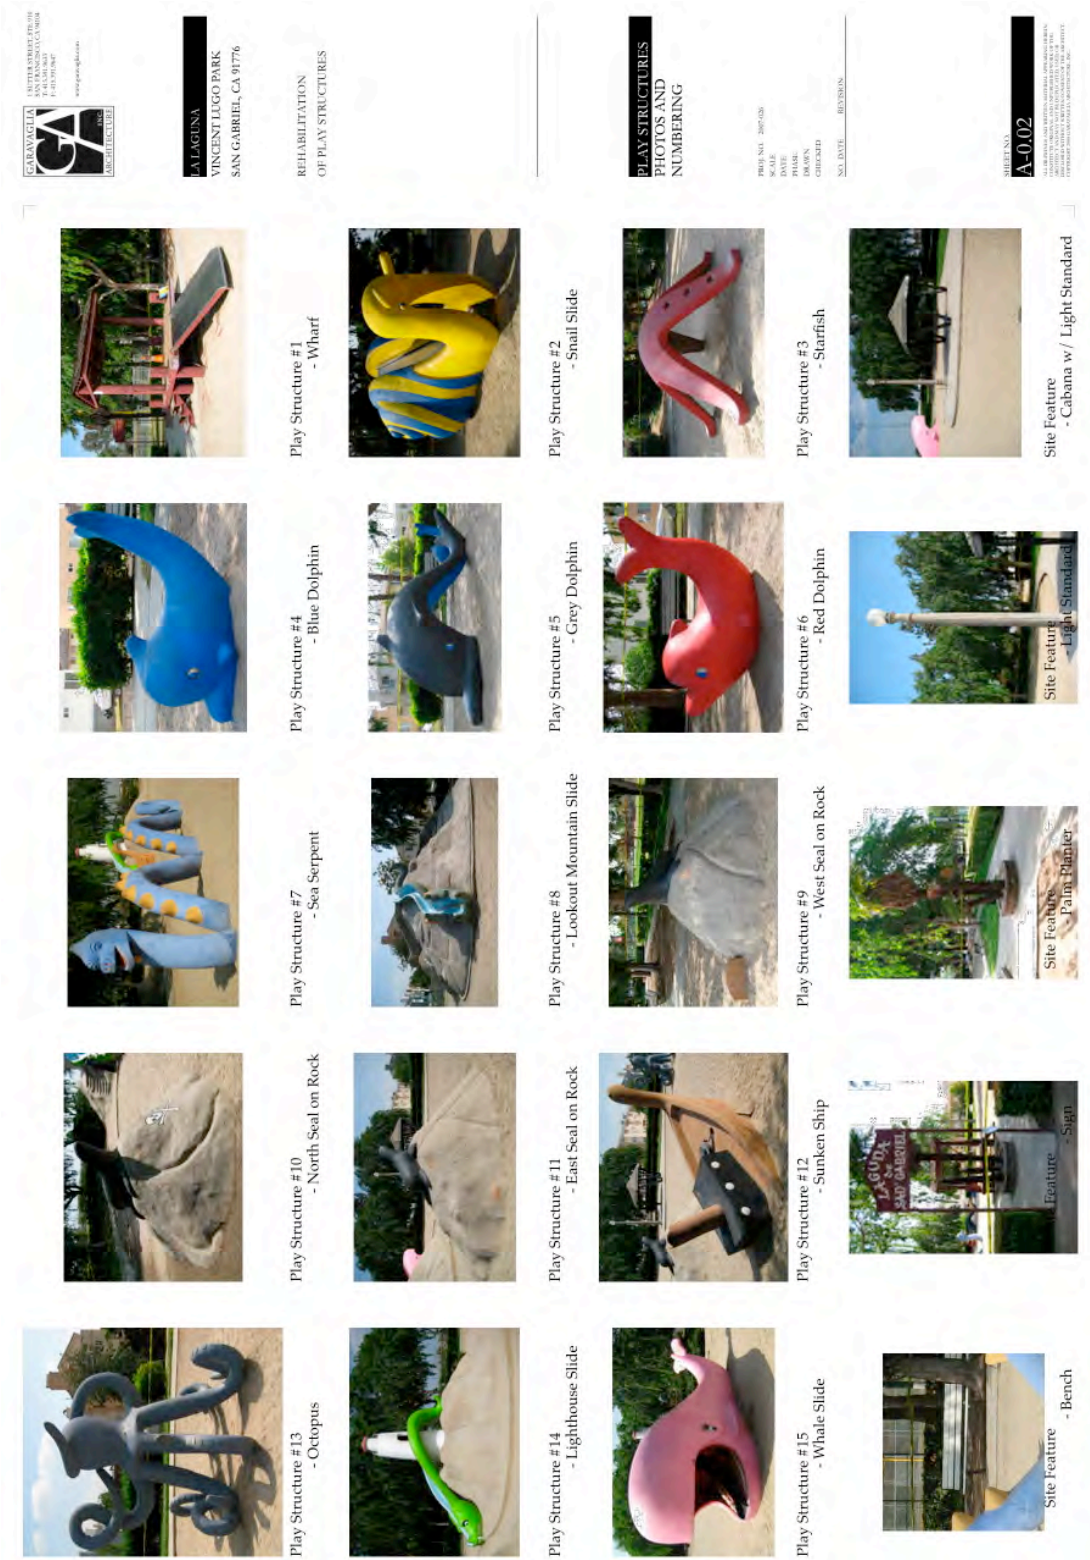
Figure 2. This photo key shows the different structures and site features found within the La Laguna de San Gabriel. A larger version of this image is found in Appendix C. Source: Garavaglia Architecture, Inc.

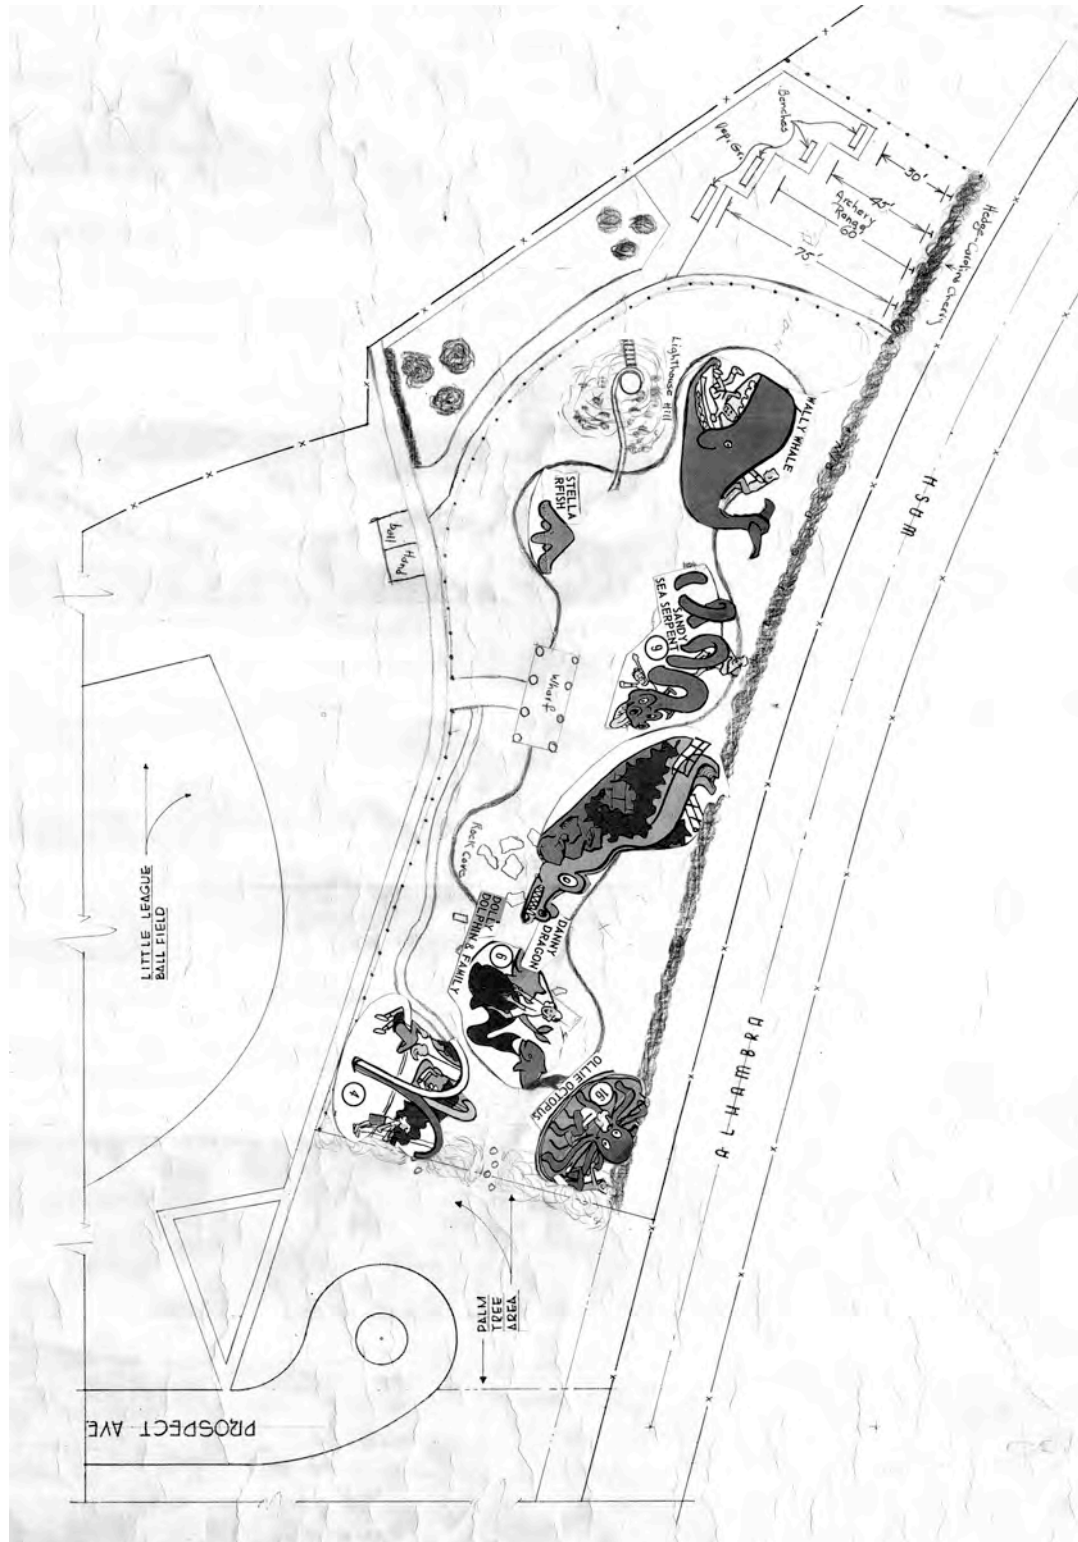
Figure 3. This is an image of the original site plan that Dominguez used to determine the layout of La Laguna. Note the handwritten, "palm grove" to the left. The figures were cut out of a brochure for Legg Lake, another of Dominguez' designs. Source: City of San Gabriel archives.

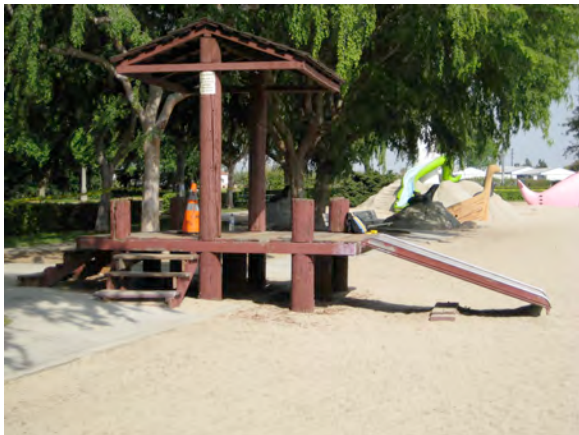
Dock (#1)

The Dock represents the official entry point from the larger park into “the Laguna.” It originally was accessed from each side by a short flight of steps up to the dock platform. Today, the gable-roofed open-sided structure retains two sets of steps that provide access from the north and west. A wide metal slide was installed at an unknown point in the past, replacing the south steps. The slide has been recently (2008) been removed because of safety concerns. Nine (9) large wood posts, each approximately eight-inches in diameter, support the platform. Some posts extend up, beyond the platform, representing piers on a wharf. A small, wood-

shingle gable roof shades the central portion of the platform.

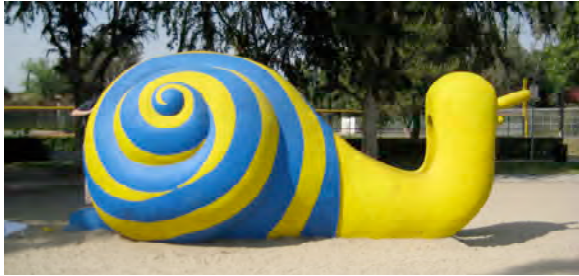
Sammy the Snail (#2)

West of the dock is a snail, "Sammy". The snail is similar in scale to the whale and, at its center, contains a metal slide. Access to the slide can be found in the rear of the snail. As with other pieces, steps were cut out of the concrete to climb to the top of the structure before sliding down and out of the snail's mouth. The snail is currently painted bright yellow and blue, and has a distinctly graded texture that is different on each side of the snail. (This piece was originally

colored maroon and gold.) The colors wind around the conch-like shell of the snail. The mouth of the snail opens around the slide and at the top of the tentacles are two blue eye-spots. The snail exhibits a very strong surface texture that highlights the craft and care that Dominguez executed on these elements. The highly tactile shell surface is a premier character-defining feature for the snail.

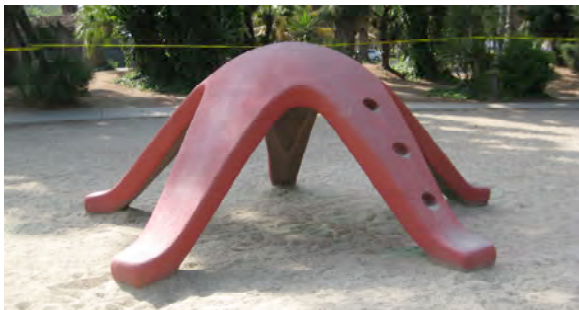
Stella the Starfish (#3)

Next to the snail sits the starfish, "Stella." It is perched on its five legs creating a space for children to crawl and hide under its body. Like the small dolphin, the starfish is also currently painted red. (Historically, it had a maroon-colored finish plaster.) On two of the legs, small notches were made so that, like other pieces, this sculpture could be climbed. The three remaining legs serve as slides back to the sand.

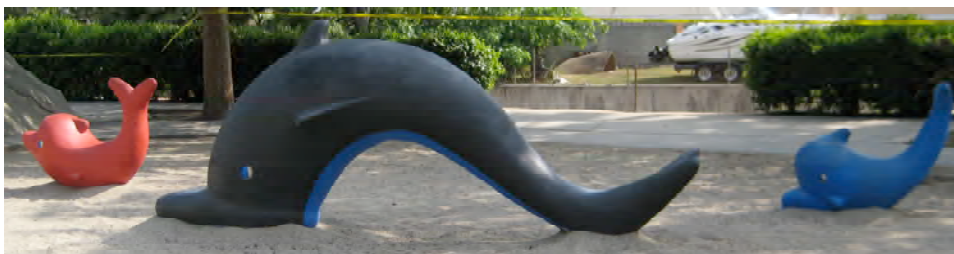
Dolphin Grouping (#4, 5 & 6)

Continuing around to the southern side of the Sandy Lagoon is another grouping of sculptures. These are the dolphin family of "Flipper", "Skippy" and "Peanut", as named by Dominguez.

The "mother," currently painted black and white, appears to be jumping though the sandy water and is frozen just as her head is about to plunge under again.

Her back arches up making a steep climb from her snout. At the top of her back, she stands about three and one half feet off the ground, but the slope to her tail is a gentle curve that creates a small slide for park users. (Historically, this element was blue with a white belly.)

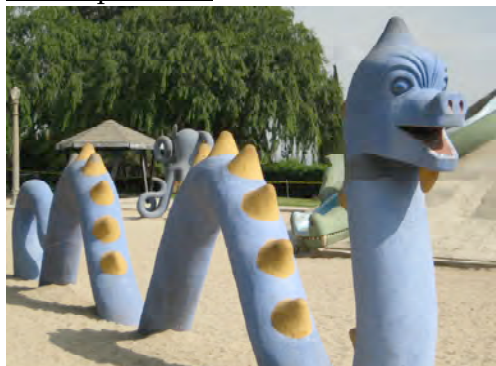
Sea Serpent (#7)

The central sculpture in the Sandy Lagoon, snaking through the middle of the Sandy Lagoon is a long blue and yellow sea serpent situated along the east-west axis. The serpent faces west and has a wide open grin that shows the remnants of a toothy smile, a concrete “beard” extends below its lower jaw. Yellow spines/ fins line the back of the sea serpent and provide toe holds for climbing. The length of the serpent submerges into the sandy lagoon three times, creating archways large enough to pass underneath the body of the serpent.

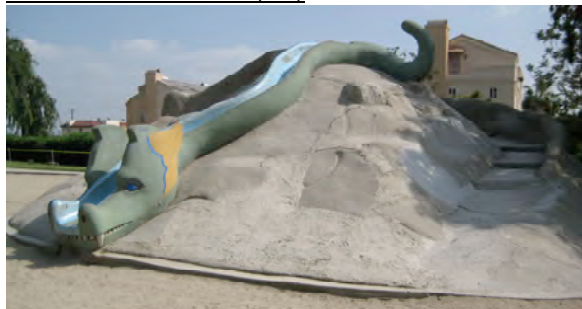
Lookout Mountain (#8)

Dominating the southern side of the Sandy Lagoon is the largest piece of La Laguna: Lookout Mountain. This sculpture reaches a height of approximately 10-15 feet and covers a significant amount of ground at its base. The sides are sloped and have the same rocky construction as the lighthouse and seals. There are two stairways to access the top of the structure, again designed for two skill levels. Facing Lookout Mountain the more gentle and

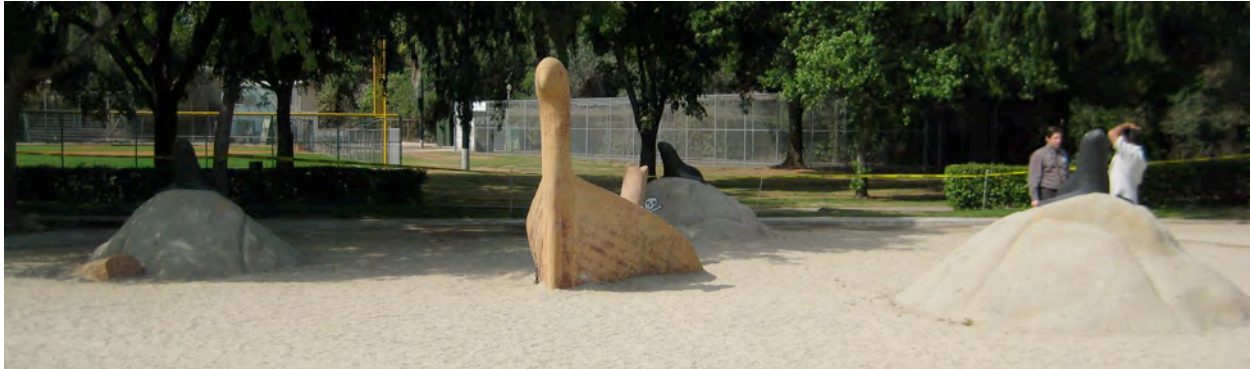
Seals (#9, 10 & 12)

To the immediate left of the dock sits a grouping of sculptures. Four pieces are placed in close proximity: three seals perched on rocks and a sinking ship. The concrete “rocks” reach a height of approximately three feet and the seals were designed with the intent that they provide a resting place. A treasure chest sits at the base of the first rock formation. It is a piece that showcases Benjamin Dominguez’s mastery of the art of “concrete wood,” also known as *faux-bois* or *trabajo rustico*. The chest is made of concrete with a grainy texture and reddish color that give it the appearance of being made from wood. Above the treasure chest the date “1765”, exactly 200 years prior to the completion of the Laguna, is scratched into the rock. The second rock and seal sculpture sits just to the east of the first. This rock is distinguished from the first with a skull and cross-bones carved into its side. It, too, stands about three feet off the ground and the seal is perched in similar fashion. The third seal shares the basic characteristics of the other two, except that it lacks a distinguishing marking on the rocks. All seals are facing south and are positioned to stand sentry over the sinking ship that completes the grouping. The seals are all currently painted black and the “rocks” below no longer have their colored surface layer. (Historically the seals were maroon and sat on beige-colored rocks.)

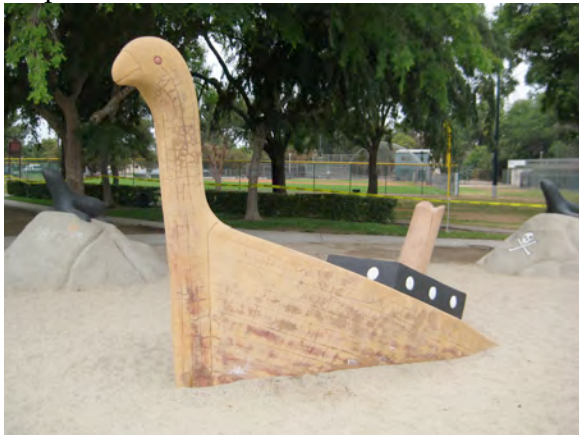
Ship (#11)

The sinking ship, christened “The Red Pirate”, is another example of Dominguez’s concrete wood. The ship appears to be 2/3 submerged, the black-painted captain’s cabin and its three white portholes is just beginning to disappear into the sand and a broken mast on top of the ship provides yet another resting place.

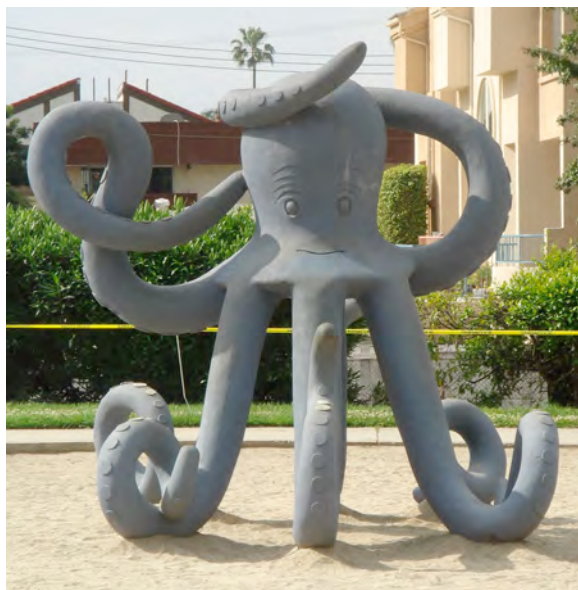
Ozzie the Octopus (#13)

Across the Sandy Lagoon, located on the southern side of La Laguna is "Ozzie," an octopus, who faces north. Ozzie retains its original muted blue color with white suckers on its tentacles, colors that were added to the concrete itself. Six of the eight tentacles support the body of the Octopus and each curves back on itself to create a series of hoops that children, to which this sculpture is deliberately scaled, can climb on and through. The two remaining tentacles are wrapped around the head of the Octopus in varying fashion. The tentacle on the right almost makes a figure eight as its tip gently touches Ozzie's head. The tentacle on the right curves up and come to rest on the top of the Octopus' head.

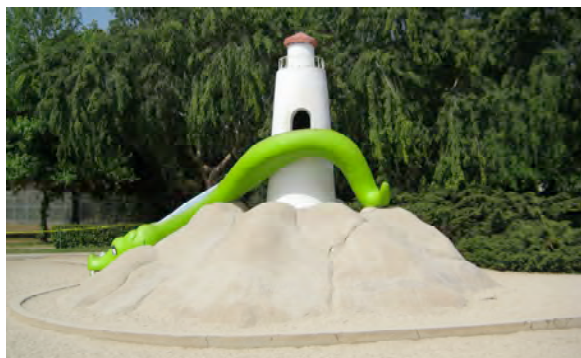
The Lighthouse (#14)

Lighthouse stands over the imaginary calamity unfolding in the seal and ship grouping of sculptures. In this play sculpture, Benjamin Dominguez combined three of his signature features: rocks, a climbing tower, and a serpentine slide. The base of the Lighthouse is a series of rocks, designed to give the appearance of a rocky-shore line. Once-small shrubs placed behind the rocky base now cover the back side of the sculpture, obscuring one of the stairways to the tower itself. Built into the front of the sculpture and the rocky base are stairs that curve from the ground to the base of the lighthouse.

The Lighthouse stands approximately twenty feet above the rocks with an iron railing at the point of the lens. A red roof adorns the top of the structure. At the base of the Lighthouse, on its northern side, a door way opens to a metal-rung ladder placed inside the cylindrical structure. The ladder extends to an exit located just beyond the mid-point of the tower. The exit gives out to a green sea monster that is wrapped around the currently painted white Lighthouse. The tail of the sea serpent rests on the rocky-base as does its neck and head. Its body is arched upward to

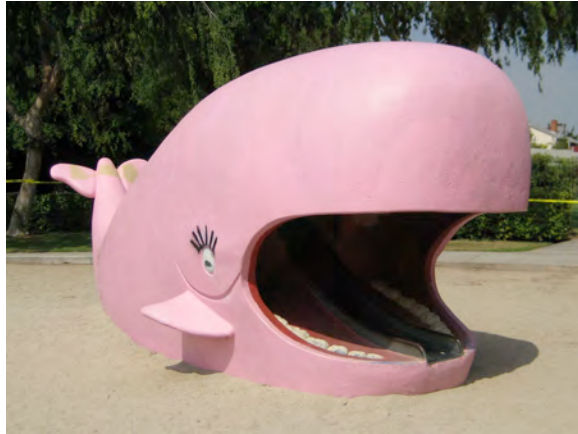
Beyond the Lighthouse, in the most eastern point of the Laguna, is another signature feature of Benjamin Dominguez's parks: the Whale. The Whale, called "Minnie" by Dominguez, is presently painted bubble gum pink with a wide smiling mouth that houses very white teeth,

notably square molars. (Historically, this element was blue.) She is oriented on a north-south axis with her mouth opening south. Running through the center of the Whale's mouth is a metal slide that can be accessed by climbing three stairs built into the west-facing side. The exterior of the Whale has a particular texture that is distinct from other pieces in the collection, namely the sea serpents. The red mouth of the Whale also has a clear texture to create the appearance of reality. The Whale's construction deviates from earlier examples of Dominguez's work because the slide and exit are in the mouth of the Whale. Most commonly the artist had created the stairway

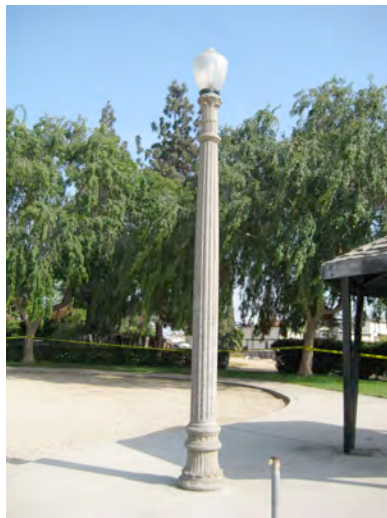
Light Standards

These light standards are believed to be original elements of La Laguna as they are depicted in the 1965 Opening Day historic photograph. These standards are a typical municipal design that was utilized in San Gabriel, and throughout Southern California, from the 1920s through the late 1960s. The fluted, tapered concrete post has a rough texture from its exposed aggregate. The "acorn" shade on several of the La Laguna standards is also a typical feature from this era. Most of these standards no longer retain their original acorn shade, making this a nice example of its type.

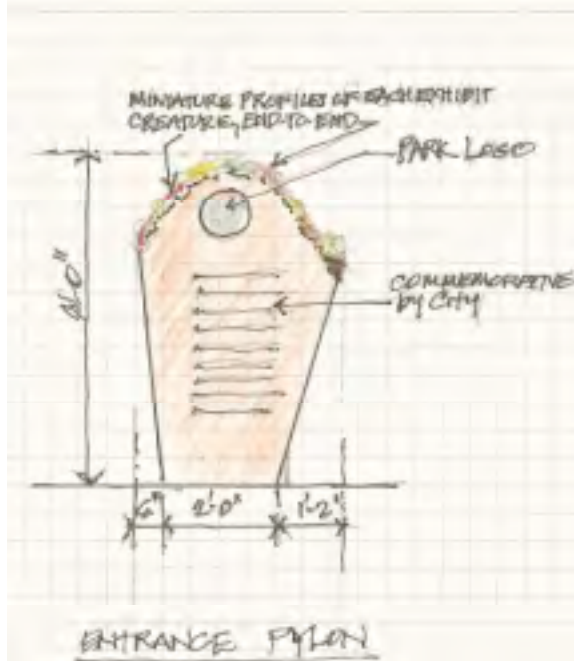
More similar to the original, this second concept (shown at left) is simpler in design. It shows a relatively flat sign of a scale and form that is more reminiscent of the original signage but with more color and detail. One option presented in this concept is to use miniature versions of the play sculptures as accents along the top of the sign. This could also be left plain.

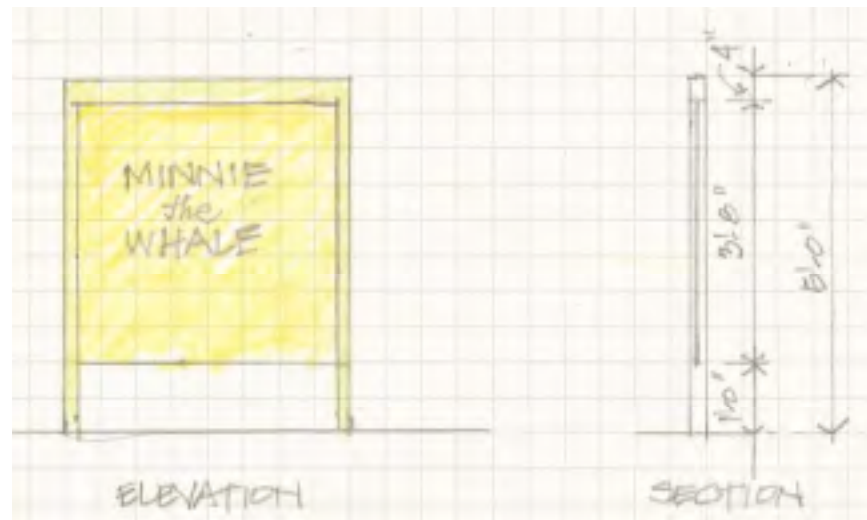
For the individual signs for each structure, there are a range of general options. The simplest is a relatively flat board stating the structure's name. These placards can be created relatively inexpensively and may contain photographs or other images to augment the text.

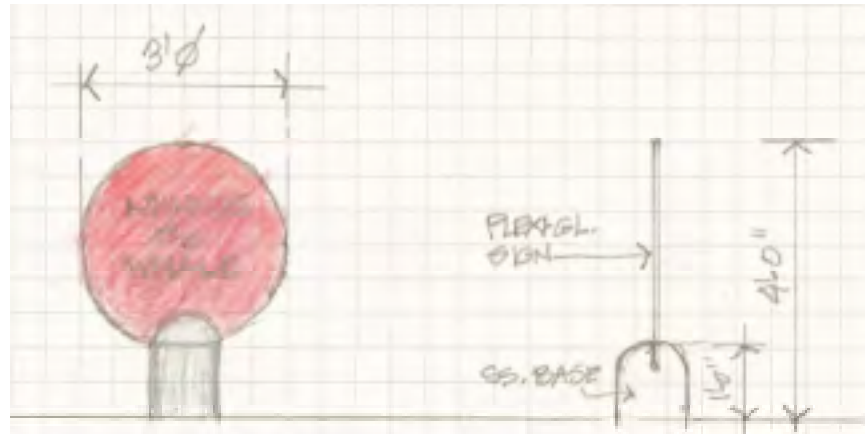
Slightly more sophisticated is an option of more graphic interest. Here the sign is semi-transparent and much more contemporary.

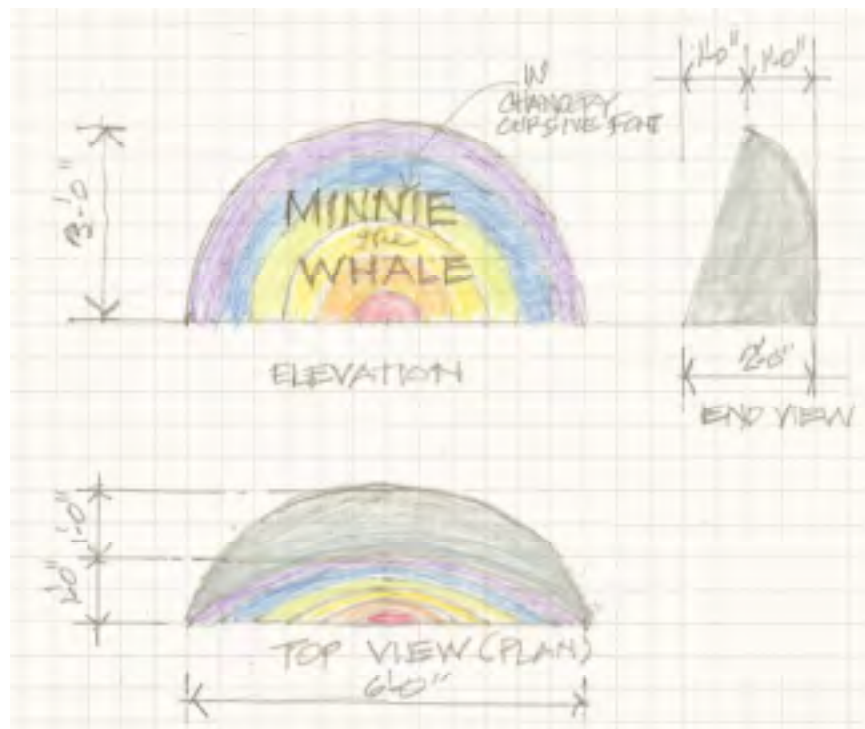
This last concept is more three-dimensional and uses the concrete forms as inspiration. The colors here are merely illustrative of the different treatments that can be used to provide additional visual interest as a backdrop for the test.
